Research Report
KTC-98-13

FIELD PERFORMANCE REPORT
ON 1219 MM HDPE (48-INCH) ON US 127
OWEN COUNTY

July 1998

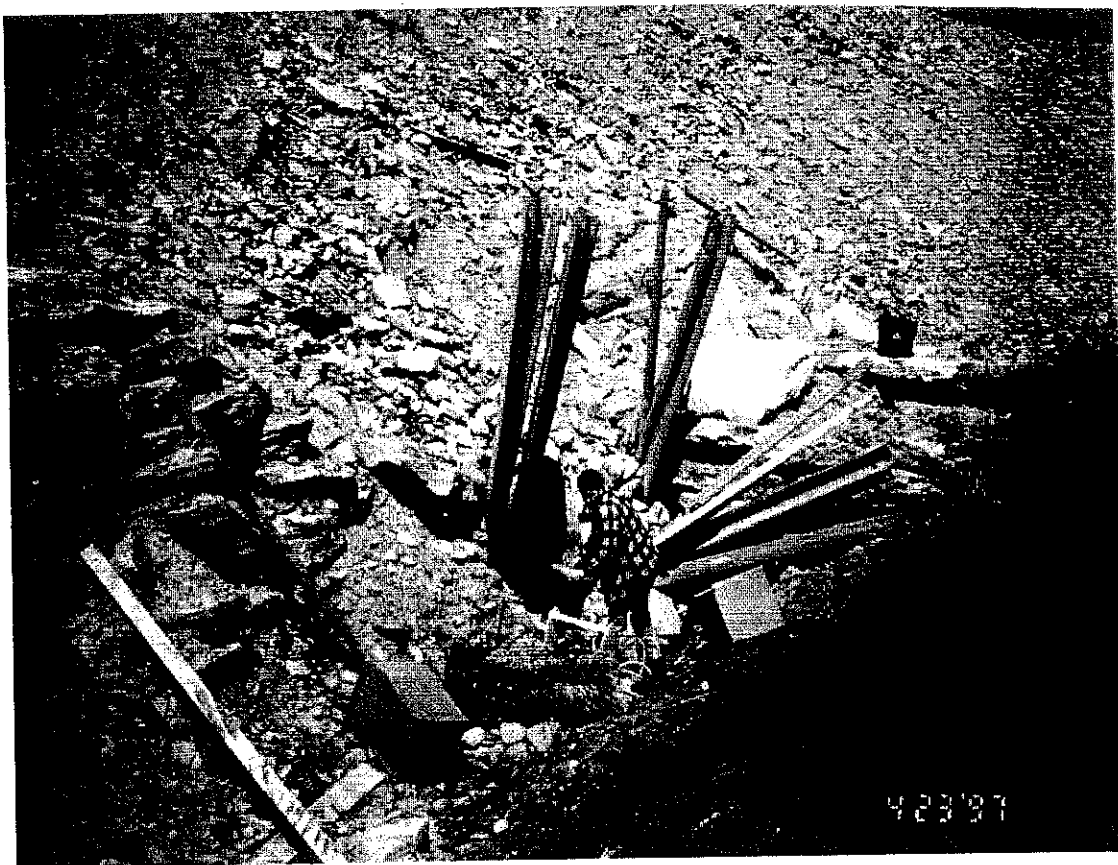
Prior to the construction of the remaining sections of the culvert, the contractor constructed a temporary retaining structure on the outlet end of the pipe to temporarily hold the embankment away from existing US 127. The structure was constructed of large slabs of limestone that had been exposed and excavated during earth work (Figure 4). Part of the structure had been placed over the outlet end of the pipe. The resident engineer requested that the structure be removed, aware of the possible damages that could be done to the drainage structure. Prior to the removal of the wall, it is apparent that the wall caused some initial damage to the structure. The load on the unsupported end of the pipe caused tension in the crown of the pipe approximately 6 feet back from the outlet end. As a result of the tension, radial cracking had occurred in approximately three areas. The cracks propagated from the crown down to the springline on each side. Employees of ADS repaired (patched) the cracks on April 23, 1997 with an extrusion welder (Figure 5 and 6). To date, the cracks do not appear to be affecting the performance of the structure.

Figure 4. Photo showing remainder of temporary retaining structure which damaged a portion of the culvert.

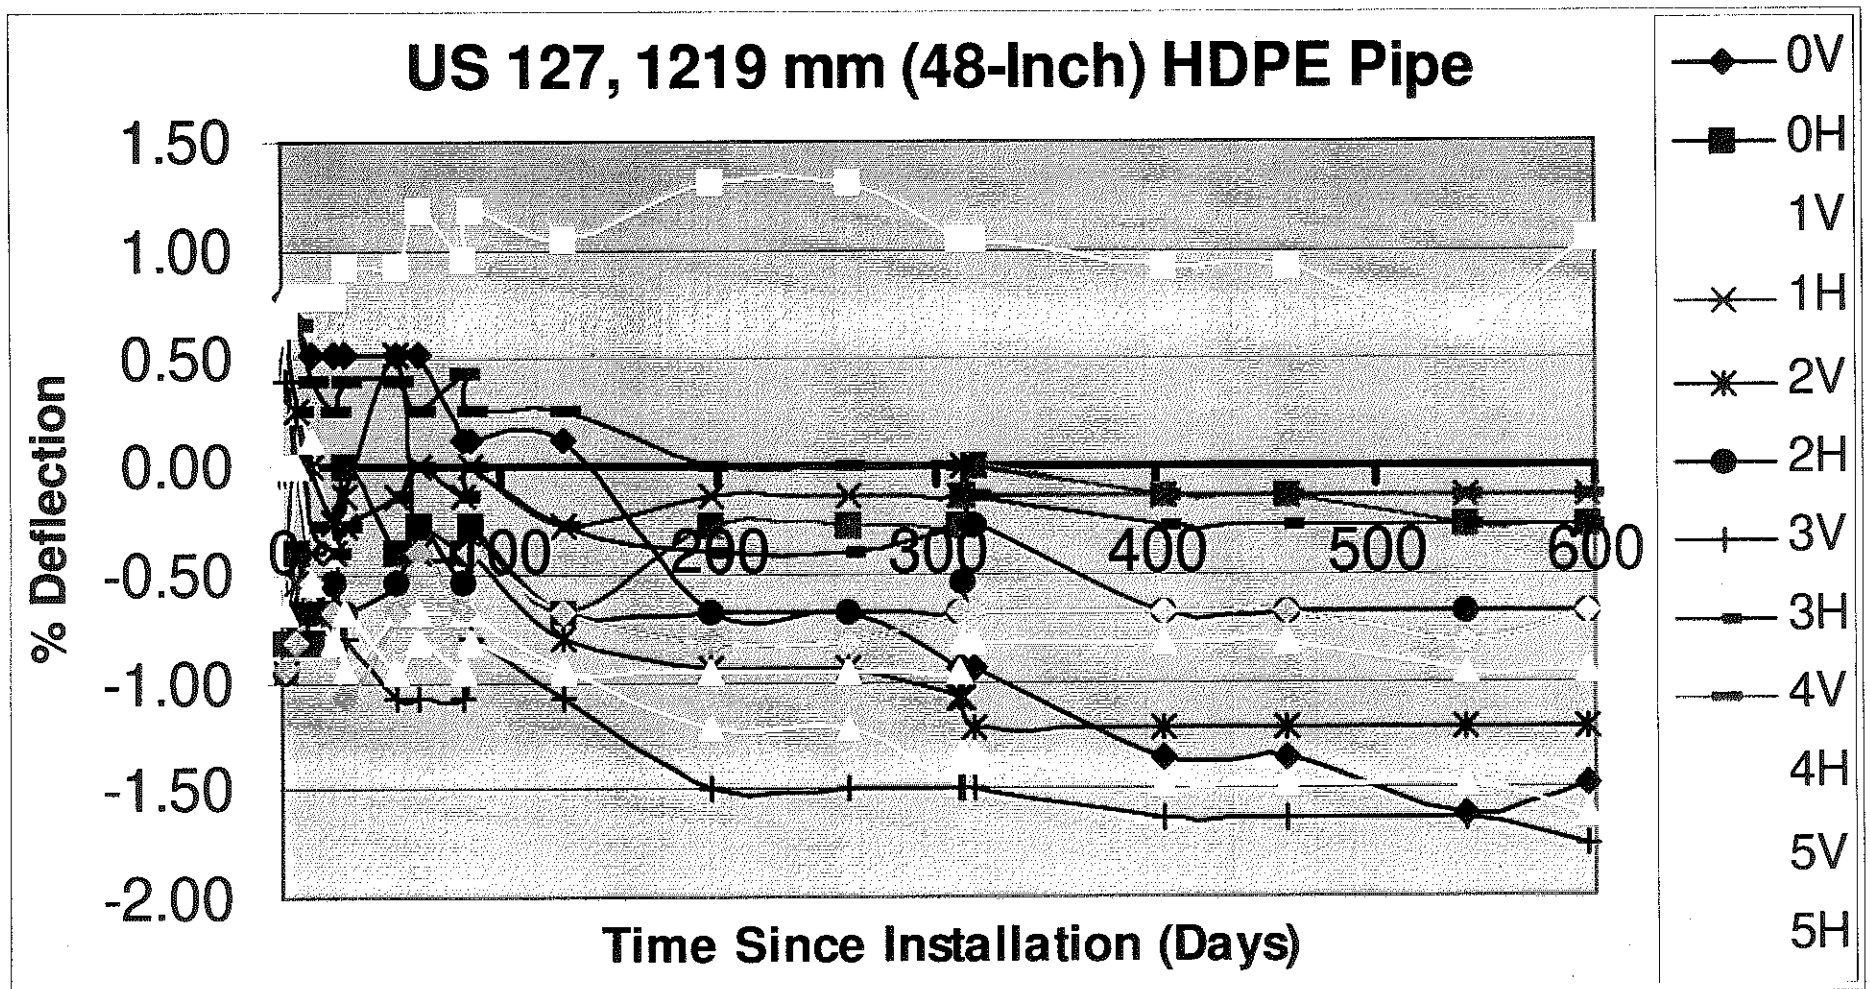
Monitoring points were placed in each section of pipe prior to backfill. Readings have been taken since construction. The last readings were taken on July 1, 1998. Deflection data are shown in Figure 11 and 12. The maximum pipe deflection recorded was approximately 2.5 percent. It is apparent from the figures that the deflections have stabilized. There also appear to be a slight difference in the performance of the pipe due to the two different backfill materials. Figure 11 indicates that the pipe sections (zero through 5) having backfill with No. 8 stone have slightly less deflection than those sections (-5 through -1) that were backfilled with pipe sand (Figure 12). In addition, the embankment height on the average is higher over the first sections of pipe.

Figure 11. Pipe deflections for pipe sections backfilled with No. 8 stone (monitoring points 0 through 5)

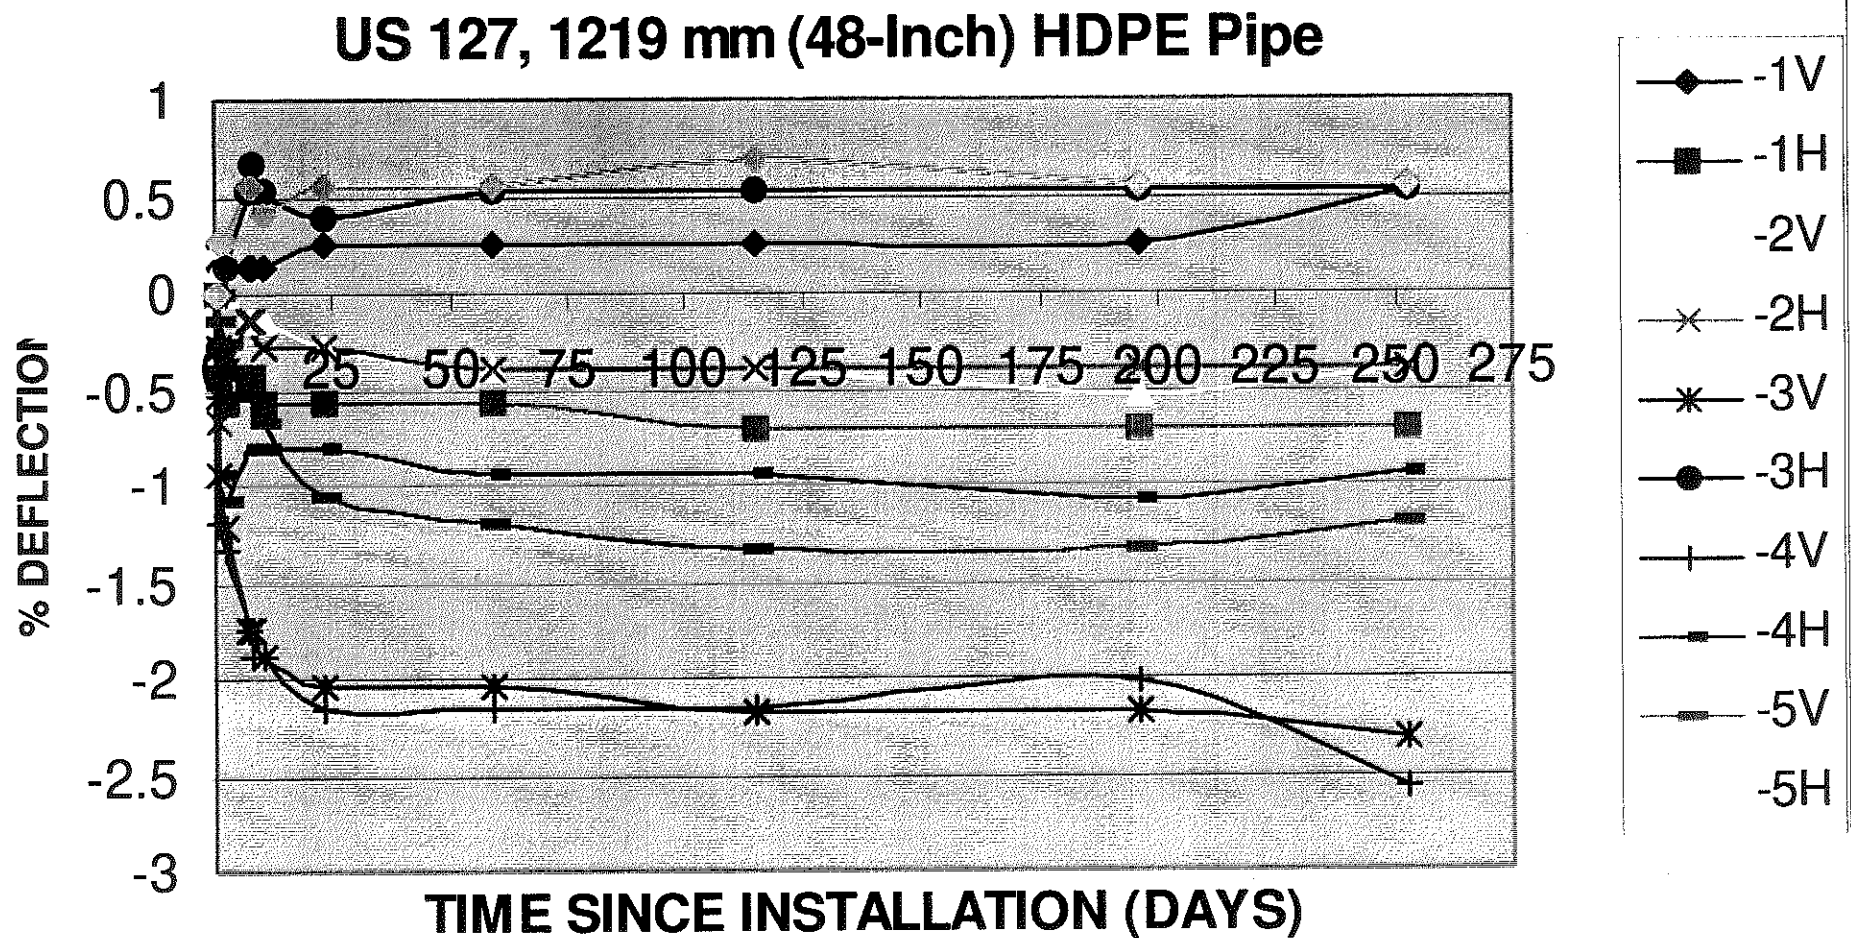
Figure 12. Pipe deflections for pipes backfilled with pipe sand (monitoring points -1 through 5)

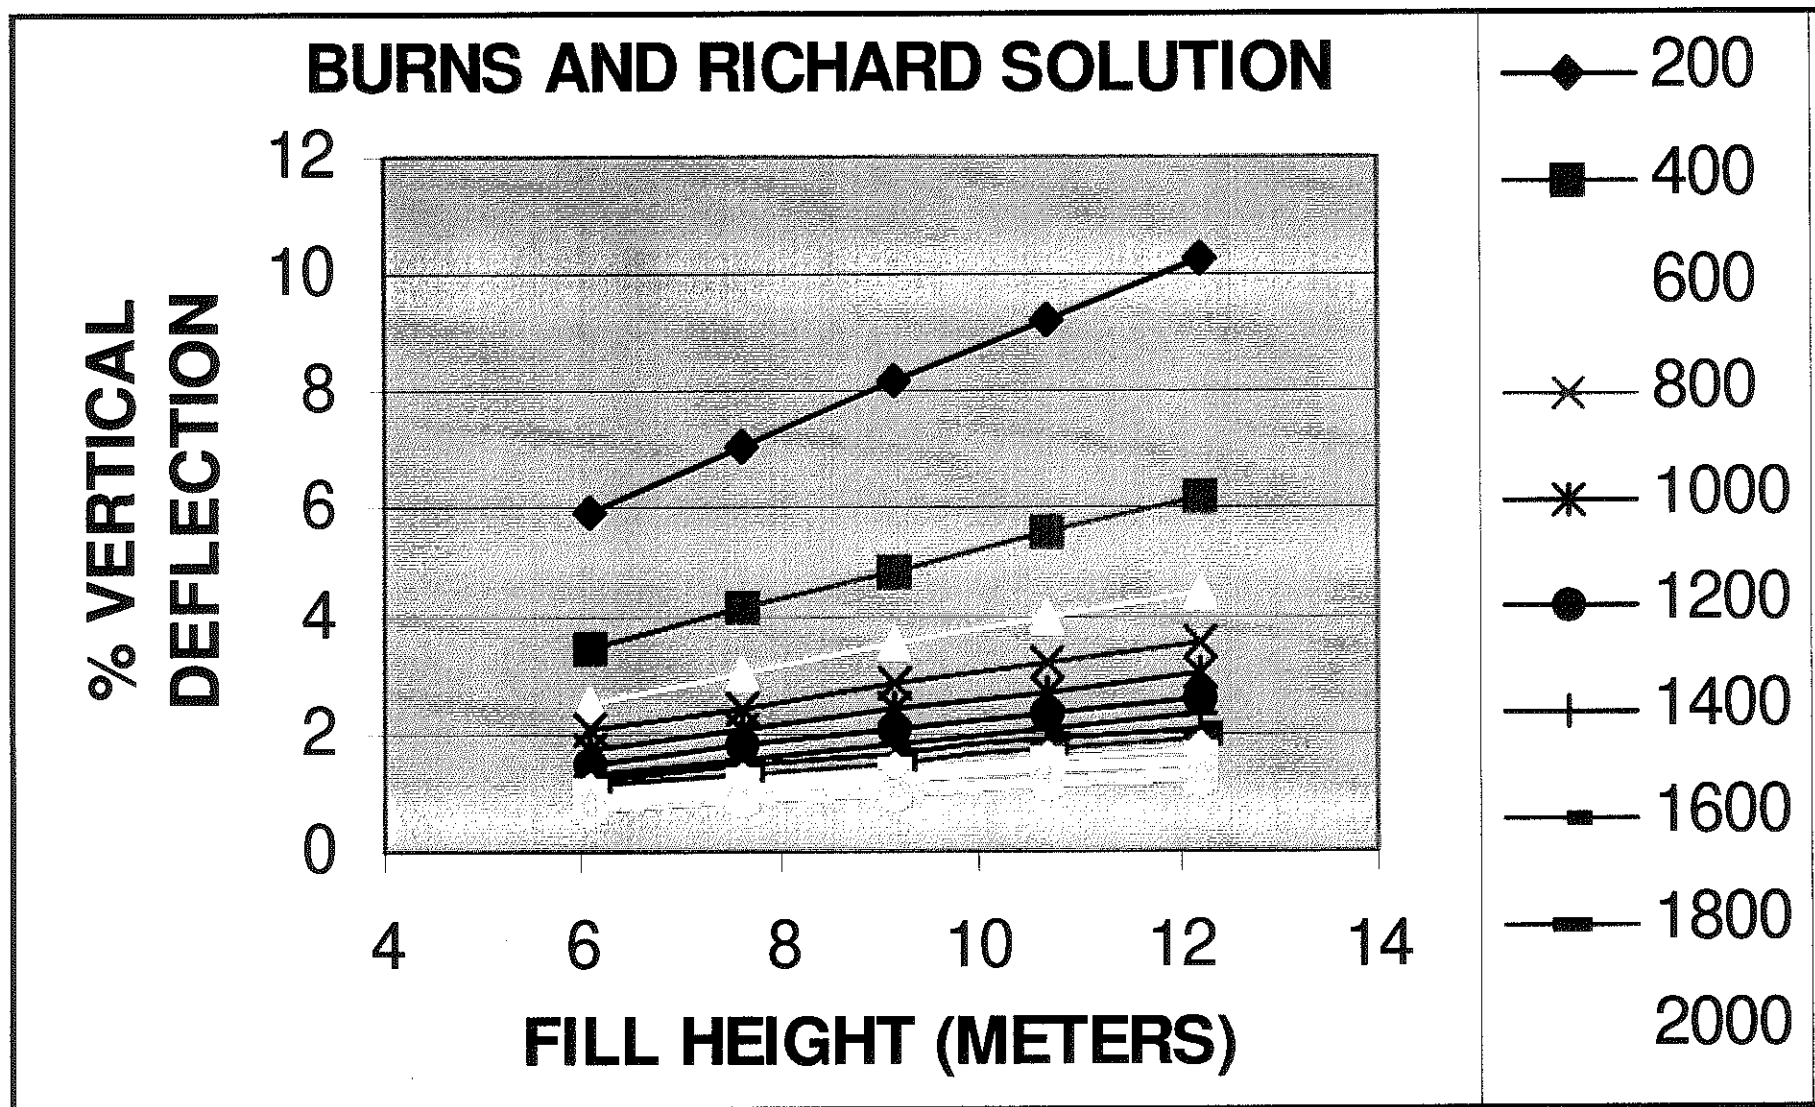
Figure 13. Predicted pipe deflections form Burns and Richard Solution with changing fill heights and backfill strengths.

The importance of the interaction between the flexible pipe and the backfill cannot be overstressed. To keep the pipe in ring compression, it is critical to provide high shear resistance at the haunches and sides of the pipe. This implies that a material having a large angle of internal friction would provide the best side support for the pipe. Manufactured aggregates are the most appropriate materials to provide and maintain high side resistance. In the case of this installation, a good backfill and bedding material was used resulting in a good installation with low vertical and horizontal deflections. The importance of good backfill is also illustrated in Figure 13 which was generated from computer runs using the Burns and Richard Solution. The solution illustrates that as the strength of the backfill is increased vertical deflections decrease. The solution also indicates that, in the case of this installation, the fill height could have been increased two fold and the deflections would have remained well below the design value of 5 percent. It is recommended that No. 8 stone be used on all flexible pipe installations in the future. It is also recommended that the permissible fill heights for HDPE pipe be increased with the stipulation that processed stone be used for bedding and backfill.
